## Chiefs Inspection Services

### Property Inspection Report

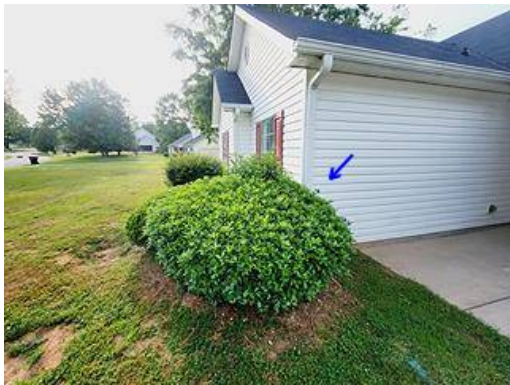
**Photo 4-1** Recommend pruning vegetation that is in contact with home

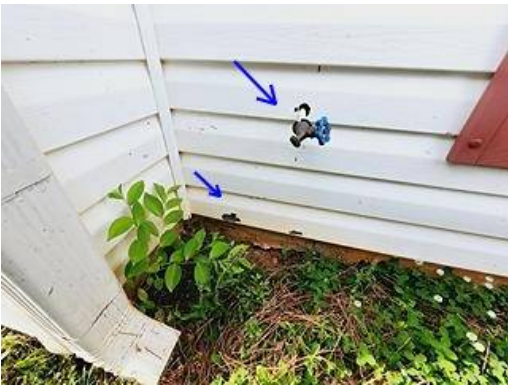
**Photo 4-2** Minor damages noted in some areas  
The hose bibb inoperable and should be secured to the home

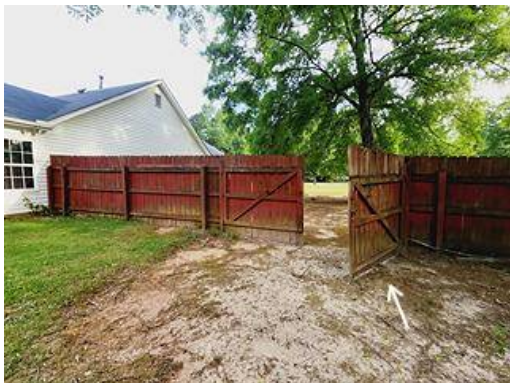
**Photo 4-3** Both left and right gates are deteriorated and difficult to close

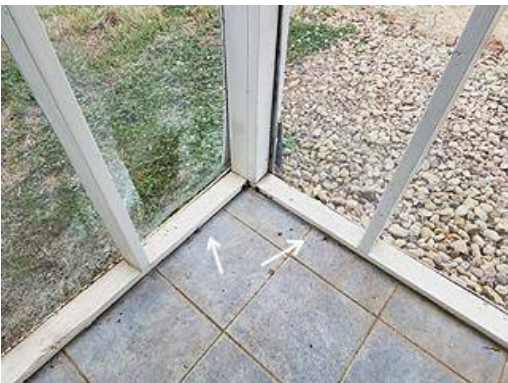
**Photo 4-4** Screen loose in some areas

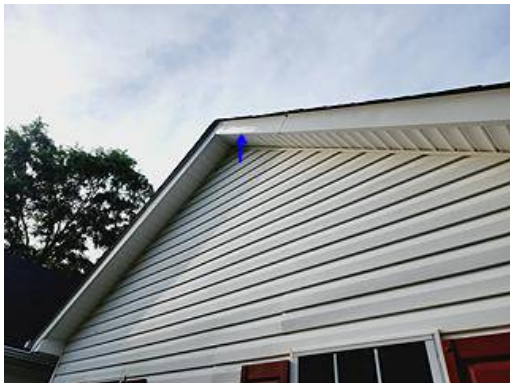
**Photo 4-5** Paint peeling in some areas

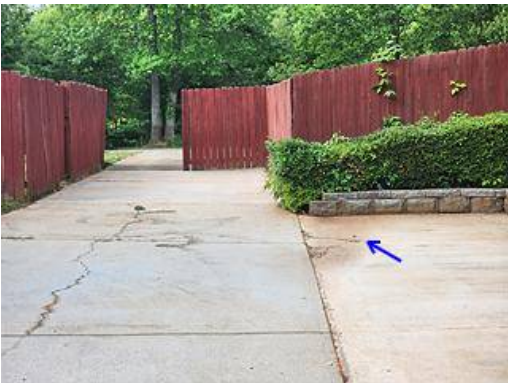
**Photo 4-6** Recommend monitoring this area after rain to ensure water is not standing. If standing water is observed have a qualified contractor evaluate and make recommendations for repairs

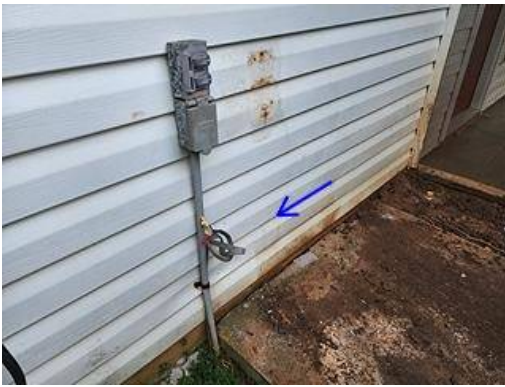
**Photo 4-7** Wire splices exposed at exterior

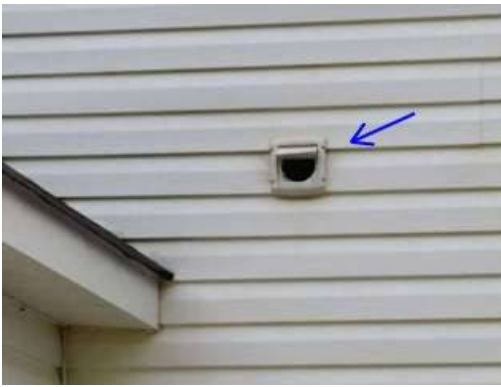
**Photo 4-8** Exhaust cap damaged/missing

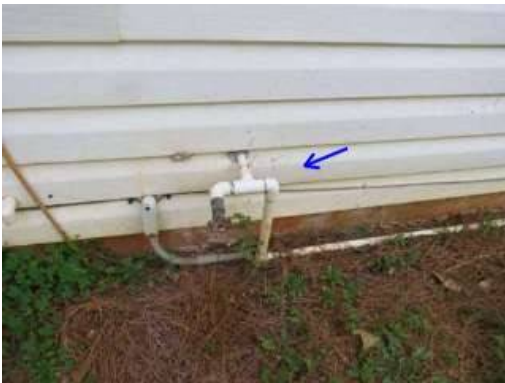
**Photo 4-9** Hose bibb loose and should be secured, severe movement can cause leaks

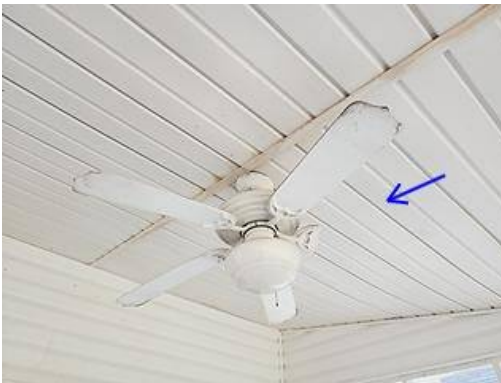
**Photo 4-10** Ceiling fan damaged

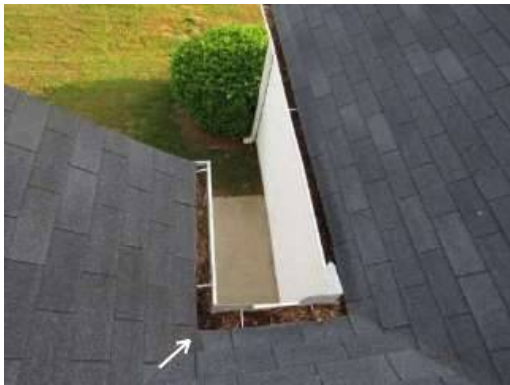
**Photo 5-1** Some gutters are full, recommend clearing as needed

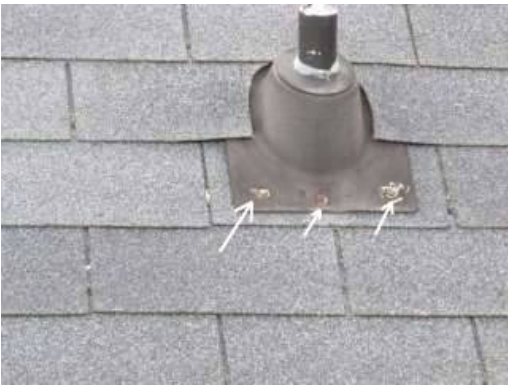
**Photo 5-2** Nail heads exposed at some areas, recommend applying sealant as needed

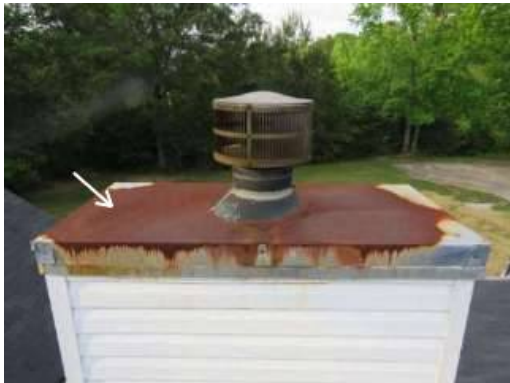
**Photo 5-3** The metal chimney cap is corroded, recommend a qualified person prep and paint the cap with anti-rust paint to prevent further deterioration and leaks

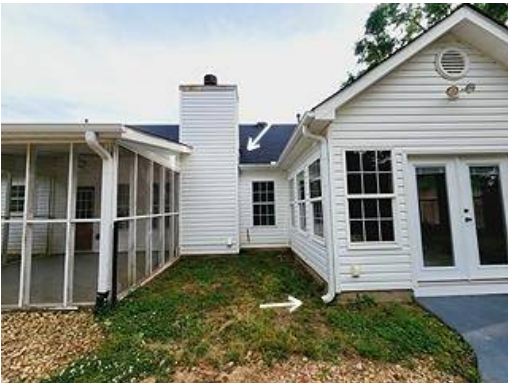
**Photo 5-4** Kick-out flashing missing at the chimney area  
Splash blocks missing

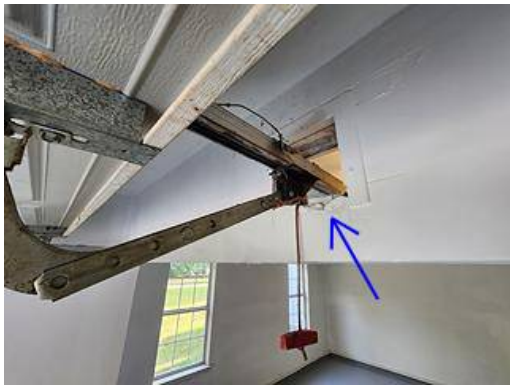
**Photo 6-1** The garage door arm hits this area when opening. Recommend a qualified specialist adjusting the opener limit to stop prior to hitting this.

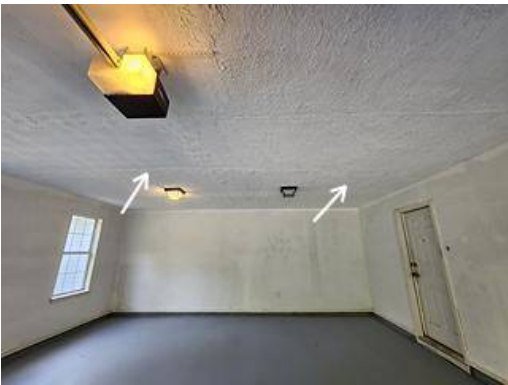
**Photo 6-2** Repairs noted in some areas of the garage ceiling. The area was dry at the time of the inspection. Recommend monitoring

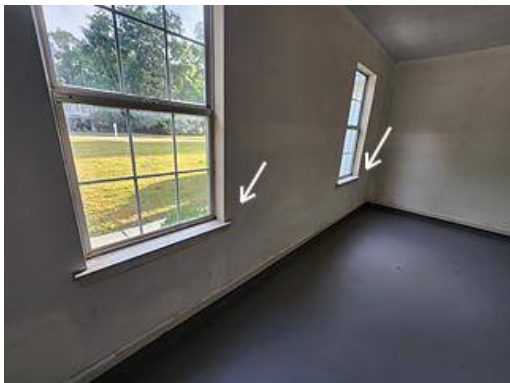
**Photo 6-3** Dry stains noted at some window sills, recommend monitoring

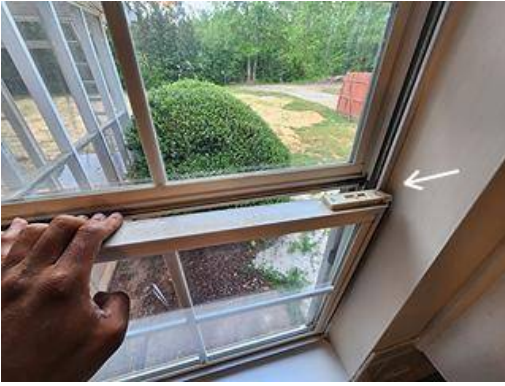
**Photo 7-1** Kitchen sink window loose on the right-side

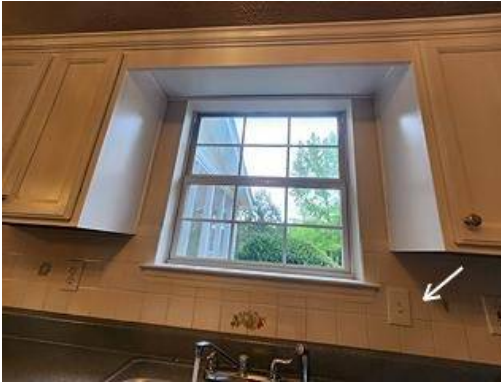
**Photo 7-2** Right side sink switch did not operated anything, recommend evaluation

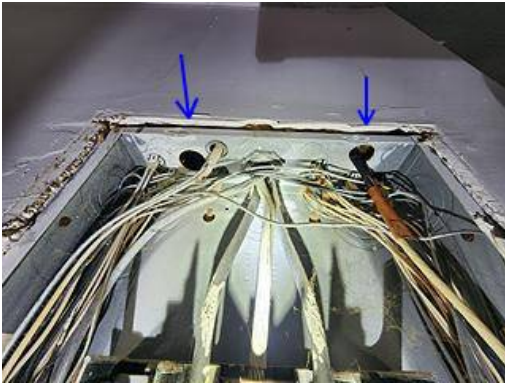
**Photo 9-1** Left-side: Knockout missing  
Right-side: Bushing missing

The below items were found in the **ELECTRIC PANEL**. Recommend a qualified electrician evaluate and make necessary repairs

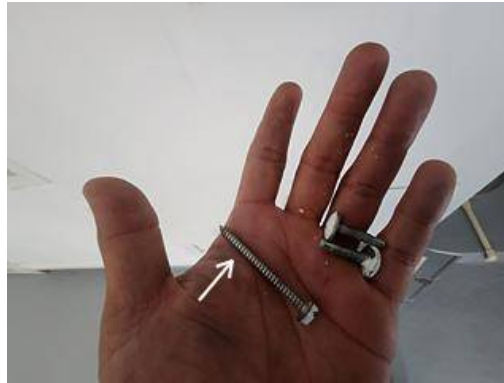
**Photo 9-2** Some panel screws are missing - One incorrect (pointed) screw used recommend replacing as needed

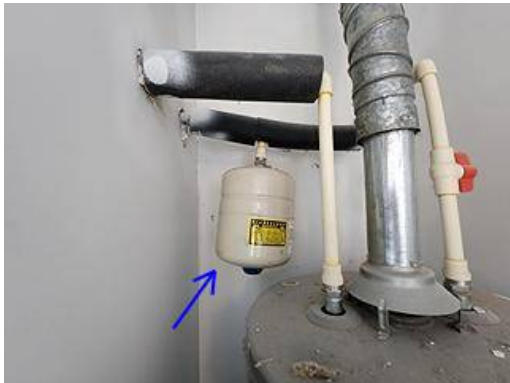
Photo 13-1

13) While inspecting the expansion tank, it did not dispel air from the valve. This should dispel air when tested. Recommend having a qualified plumbing contractor evaluate and repair or replace as necessary. These should be tested annually.

The expansion tank should also be properly supported to prevent stress on supply line

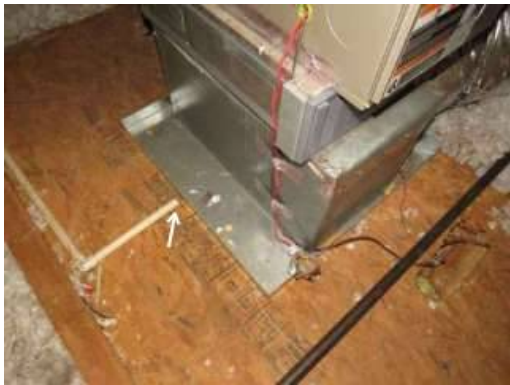
16) Recommend that a PVC condensate drain line be installed from the air handler drain pan to the exterior of the house. This line will encourage condensate water to drain from the pan in the event that the moisture sensor in the pan fails. The system does have a moisture sensor. Issue noted at the attic unit.

**Photo 16-1** Drain pan drain line disconnected from drain pan

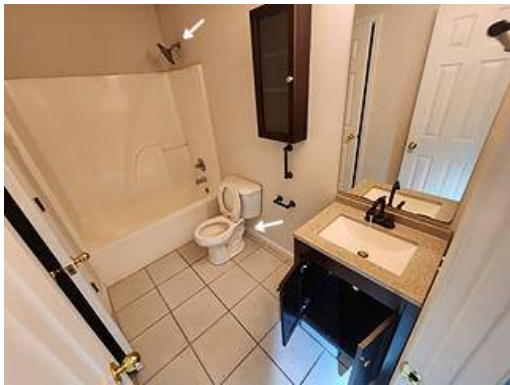
**Photo 23-1** Hall bathroom toilet and showerhead are loose

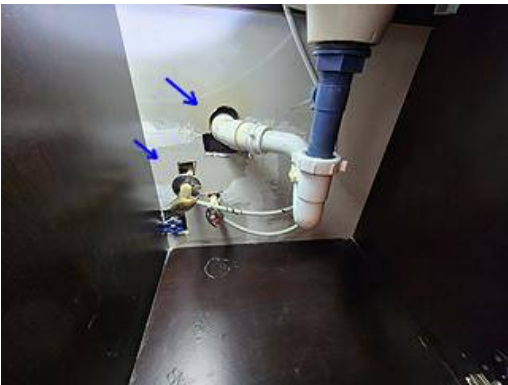
**Photo 23-2** Recommend sealing all openings below hall sink

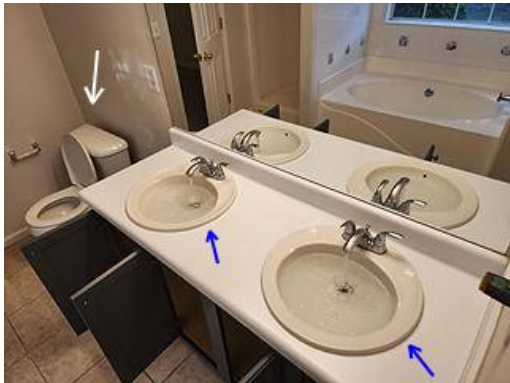
**Photo 23-3** Master bathroom toilet loose  
The left side sink has stress cracks - no leaks observed due to cracks  
The right-side sink drains slowly, recommend clearing as necessary

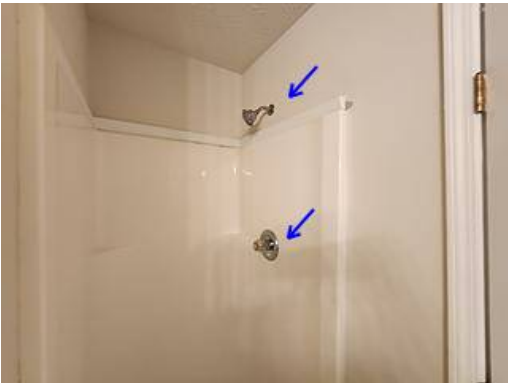
**Photo 23-4** Shower head and handle loose in master bathroom

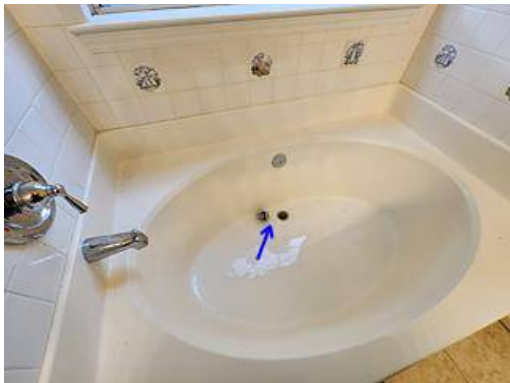
**Photo 23-5** Master bathroom drain stopper is detached

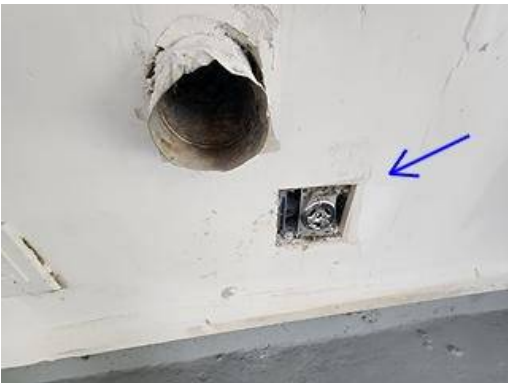
**Photo 23-6** Dryer 3-prong, most new outlets are 4 prong. Dryer outlet cover missing

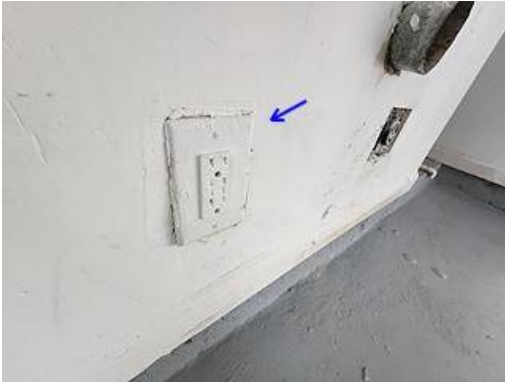
Photo 23-7 Laundry GFCI outlet loose

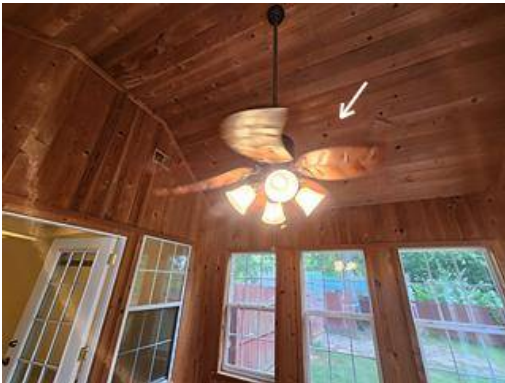
Photo 24-1 Sunroom ceiling fan wobbly

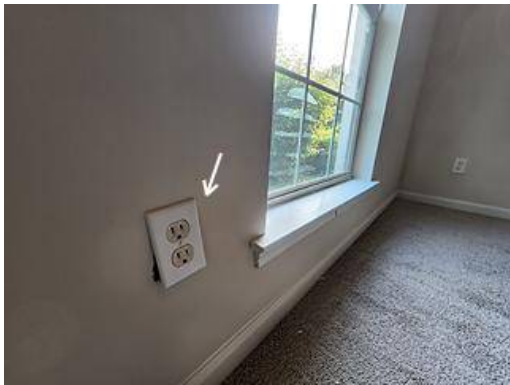
**Photo 24-3** Some outlet covers are loose, recommend securing as needed - Front bedroom

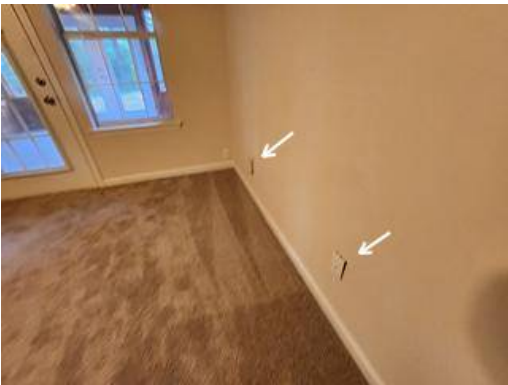
**Photo 24-4** Outlet covers loose, master bedroom

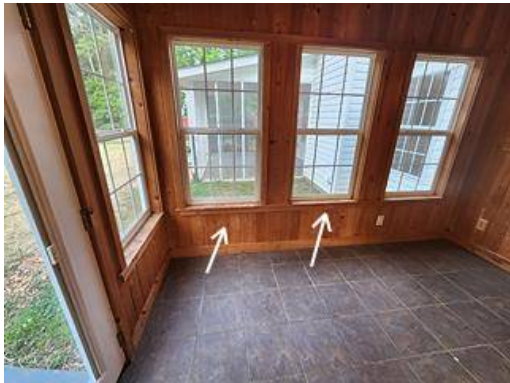
**Photo 24-5** Dry stains

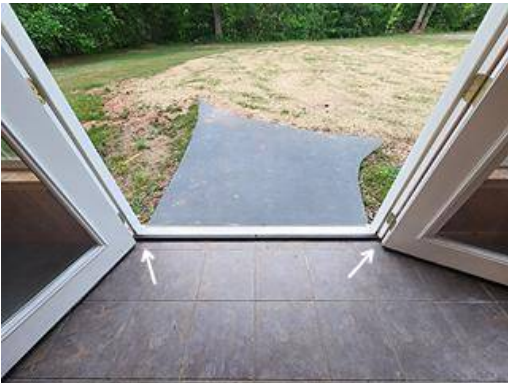
**Photo 24-6** Repairs noted, dry stains observed. Recommend monitoring

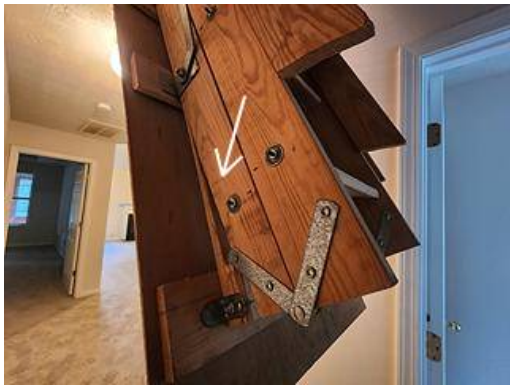
**Photo 26-1** Attic stairs damaged

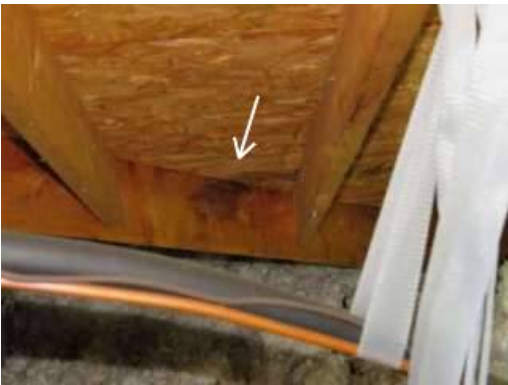
**Photo 26-2** Dry stains noted in some attic areas. These areas were dry at the time of the inspection. Recommend monitoring in the future and if necessary have a qualified contractor evaluate and make any needed repairs

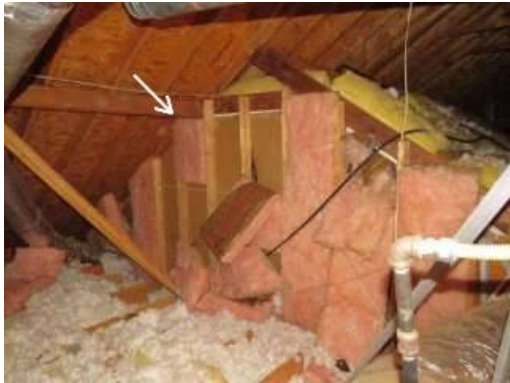
**Photo 26-3** Insulation fallen in some areas above the living room. Also noted with the thermal camera

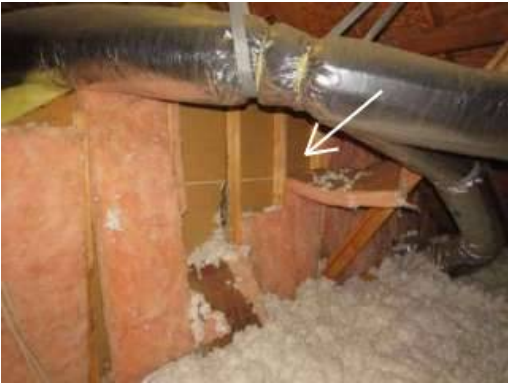
**Photo 26-4** Insulation fallen

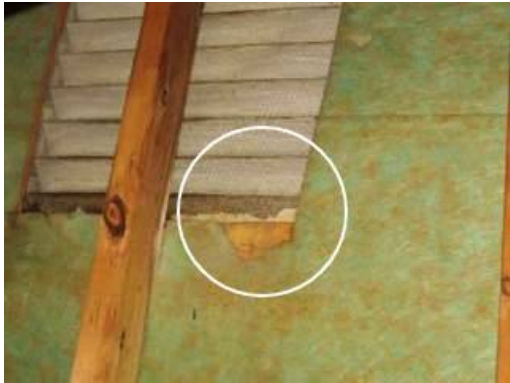
**Photo 26-5** Gable screen damaged

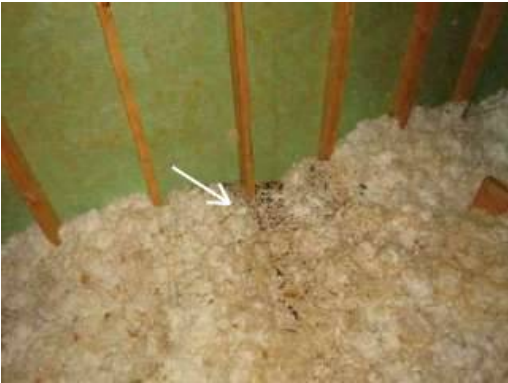
**Photo 26-6** Droppings observed below damaged gable screen

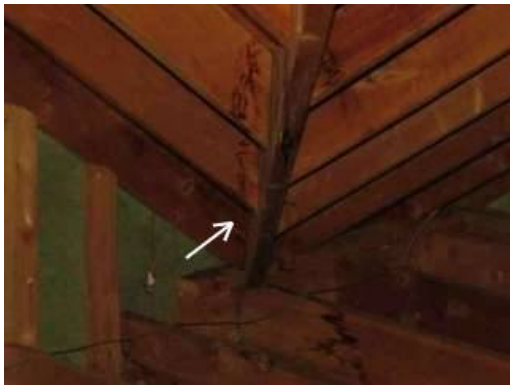
Photo 26-7 Dry stains

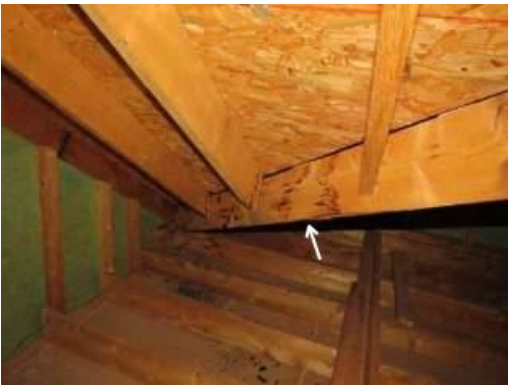
Photo 26-8 Dry stains

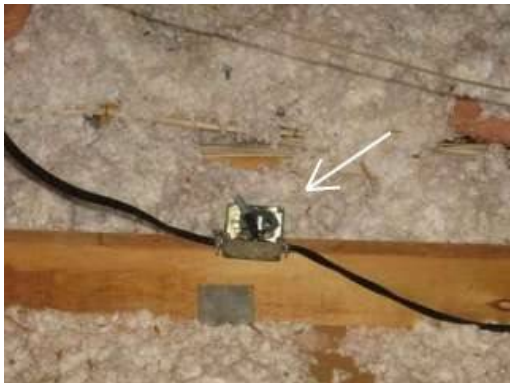
Photo 26-9 Exposed splices noted in some areas

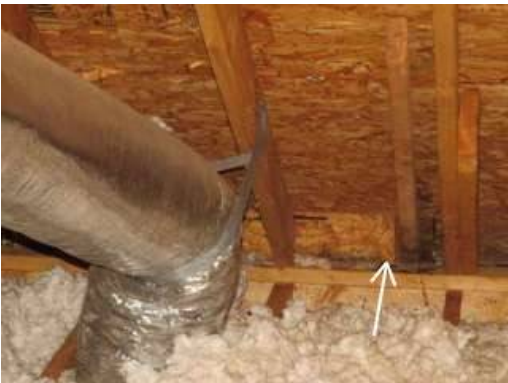
Photo 26-10 Dry stains chimney area
