## Chiefs Inspection Services

### Property Inspection Report

McDonough, GA

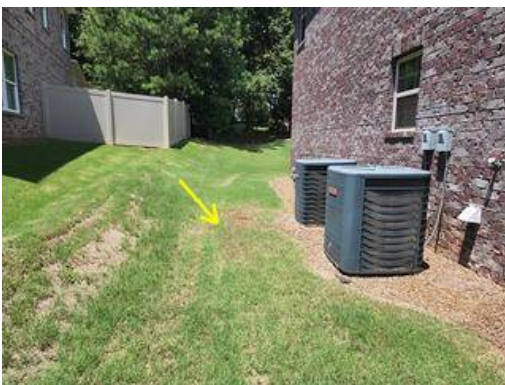
2) ⓘ Evidence of past accumulated water were found at one location in the yard or landscaped areas, and no drain was visible. If evidence of past water was found (e.g. silt accumulation or staining), monitor these areas in the future during periods of heavy rain. If standing water exists, recommend that a qualified person repair as necessary. For example, installing one or more drains, or grading soil.

Photo 2-1 Left side of home

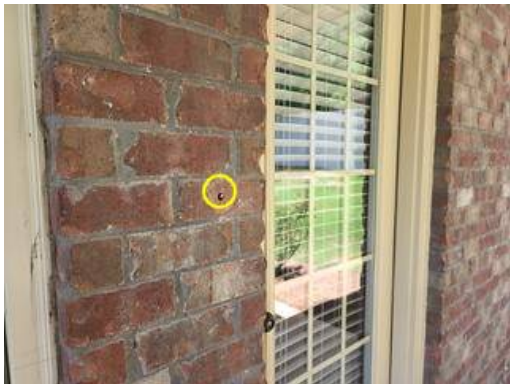
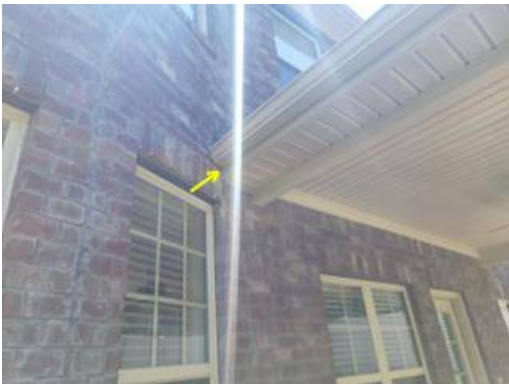
One or more holes or gaps were found in siding or trim. Vermin, insects or water may enter the structure. Recommend that a qualified person repair as necessary.
-

Photo 5-1 AT rear entrance

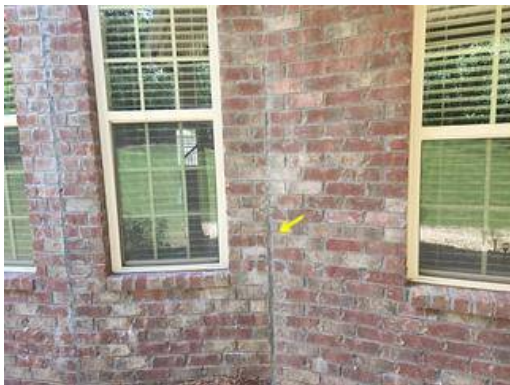
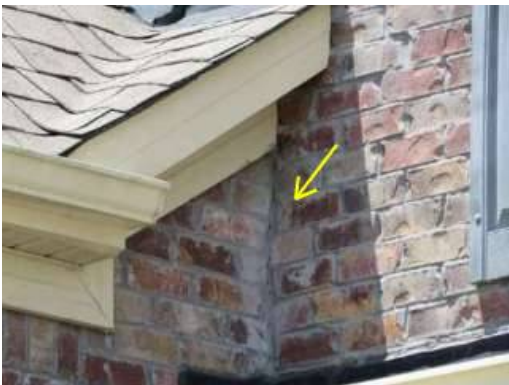
Minor cracks were observed in some areas of the brick veneer mortar. Where cracks or openings are exposed, water may enter the wall structure causing mold, fungal growth and structural damage. This is a conducive condition for wood-destroying organisms. Recommend that a qualified contractor repair as necessary.
-

Photo 6-1 Rear of home

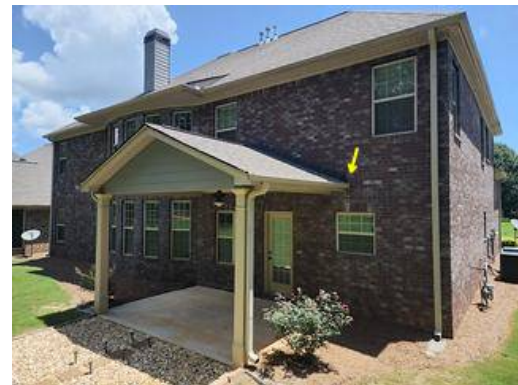
Kick-out flashing was missing at one or more locations. Such flashing should be located at the bottom of slopes where roof surfaces intersect with exterior walls above. It directs rainwater away from exterior walls and into gutters so that rainwater is less likely to run down the front surfaces of siding or flow behind siding. Recommend that a qualified contractor install kickout flashings where missing and per standard building practices.

Photo 8-1 Both sides of patio cover

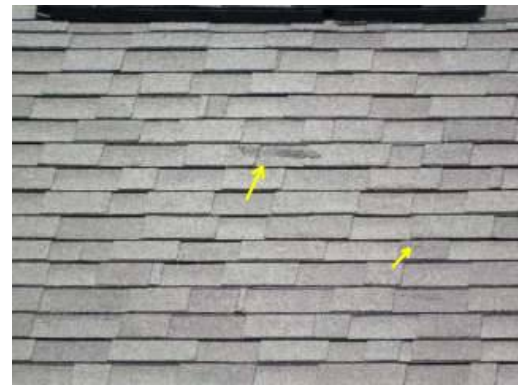
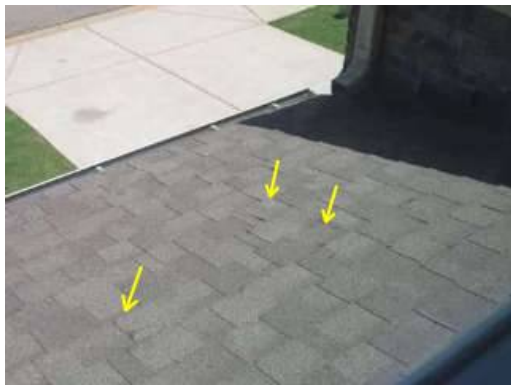
Some composition shingles were damaged. Leaks can occur as a result. This is a conducive condition for wood-destroying organisms. Recommend that a qualified contractor repair as necessary. For example, by replacing shingles.

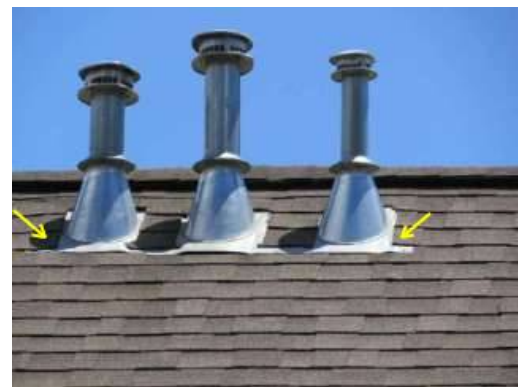
Nail heads were exposed at some roof vents. Recommend applying an approved sealant over exposed nail heads now and as necessary in the future to prevent leaks.

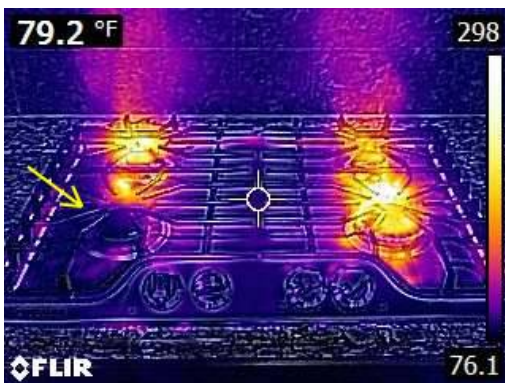
Photo 15-1

1 cooktop burner was inoperable. Recommend that a qualified person repair as necessary.

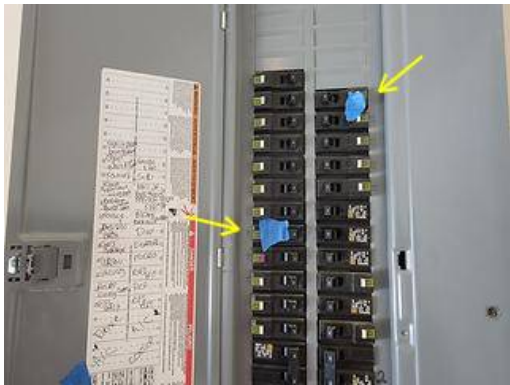
Photo 22-1

22) Some breakers have painters tape attached to them, and some panel screws are missing. Recommend asking the seller about this and if necessary have a qualified contractor evaluate and repair as necessary.

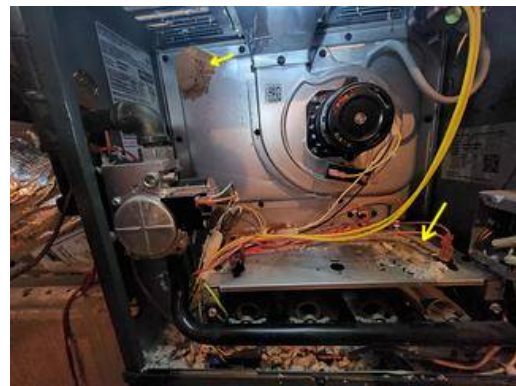
Photo 27-1

There was insulation and Mud daubers nest inside the #2 furnace cover. Recommend a qualified person evaluate and make repairs as necessary

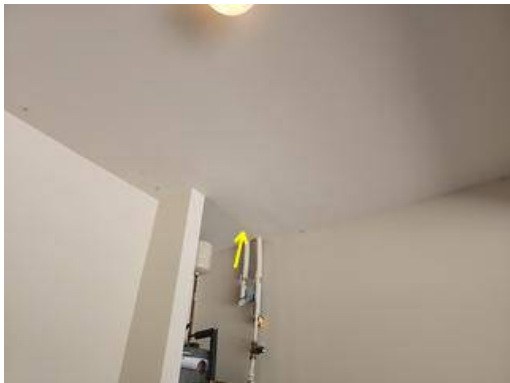
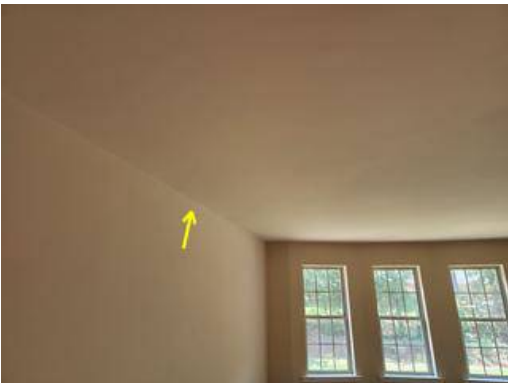
** Repairs were found in one or more ceiling areas. However, no elevated levels of moisture were found. The stain(s) may be due to past roof and/or plumbing leaks. Consult with the property owner and monitor the stained area(s) in the future, especially after heavy or prolonged rain. If elevated moisture is found in the future, then recommend that a qualified contractor evaluate and repair as necessary.

Photo 38-1 Garage area

Photo 38-2 Living area ceiling

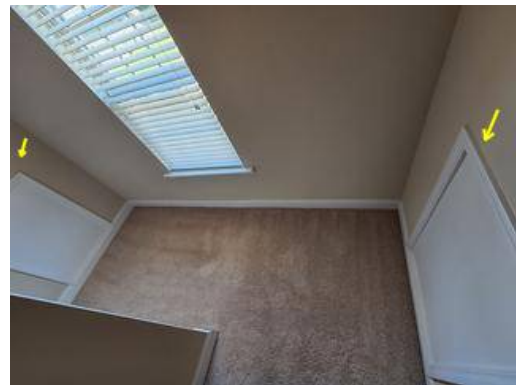
Photo 41-1

2 small attic areas in the master closet were sealed shut, these areas are excluded from the inspection
