## Chiefs Inspection Services

### Property Inspection Report

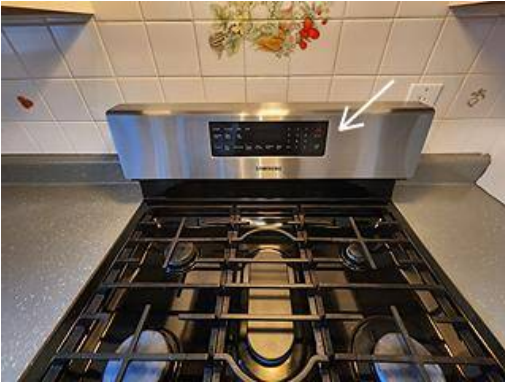
**Photo 7-3** The stove was off at the time of the inspection

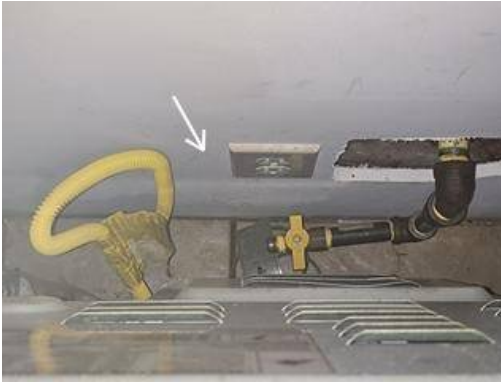
**Photo 7-4** Unplugged, gas disconnected, exposed gas valve should be capped

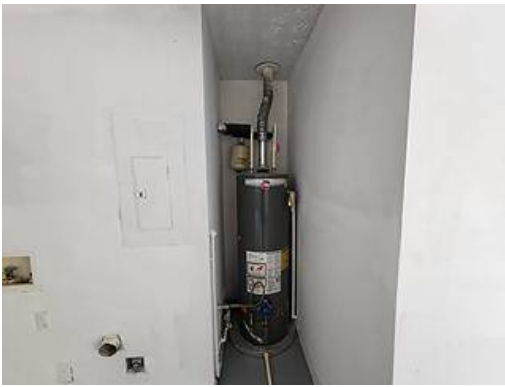
**Photo 14-1** Rheem gas water heater  
Garage location

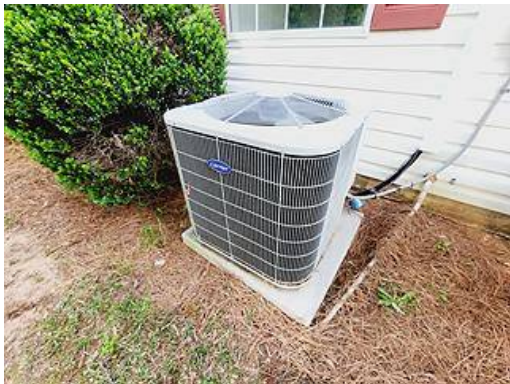
**Photo 18-1** Carrier AC unit  
Left side of home

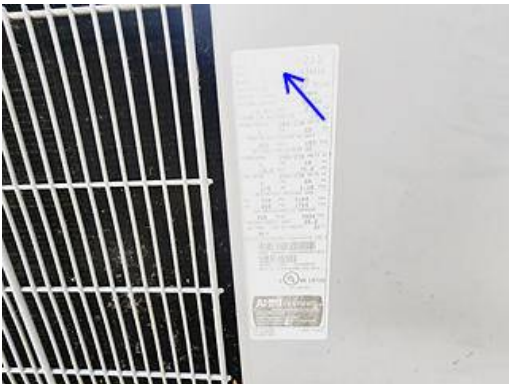
**Photo 18-2** Manufactured 2014  
3-ton unit

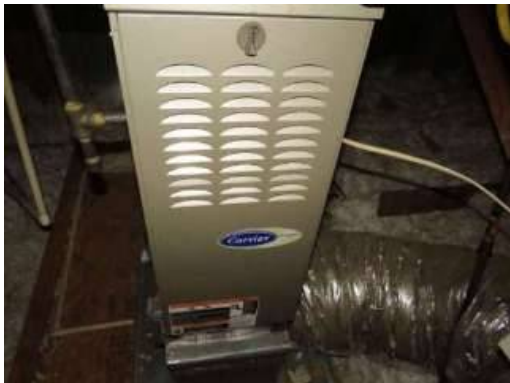
**Photo 18-3** Carrier air handler unit  
Attic location

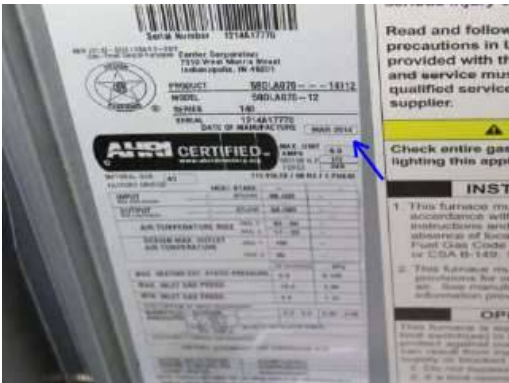
**Photo 18-4** Manufactured 2014  
Filter behind grill in hall, and at air handler base

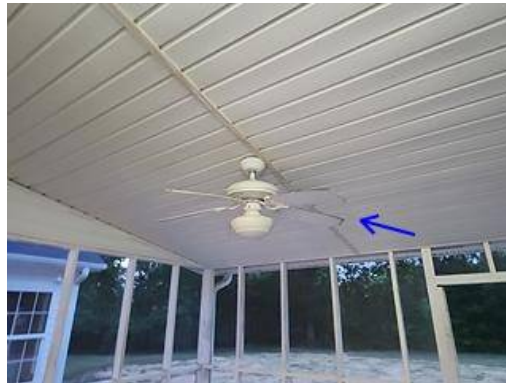
Photo 24-2 Screened in porch ceiling fan appears inoperable

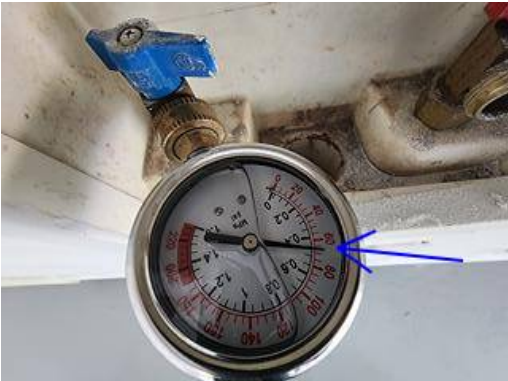
Photo 27-4 Water pressure @ 70psi
