## Chiefs Inspection Services

### Property Inspection Report

McDonough, GA

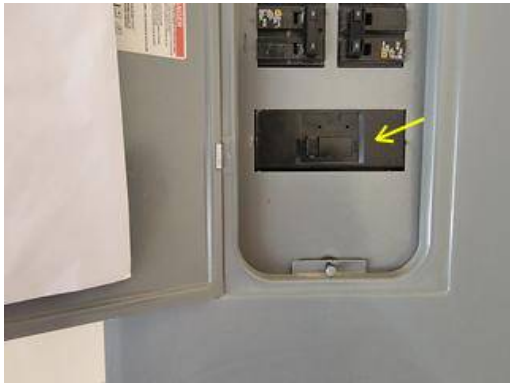
23) Main shut off location

Photo 23-1 Bottom of service panel

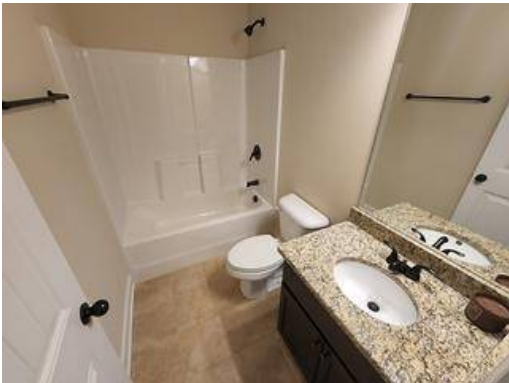
Photo 36-3 Jack & Jill bathroom

**34)** The below items were found in the **\*JACK & JILL BATHROOM\***. Recommend a qualified contractor/plumber evaluate and make necessary repairs

- 1. Water was discolored when the bathtub was filled. This can be caused by water stagnating in water supply pipes, rust accumulating in pipes or in the water heater, or sediment being present in the water supply. Recommend flushing the water supply piping and the water heater. If that fails to resolve the issue, then have a qualified plumber evaluate and repair as necessary.
- 2. The toilet is loose
- 3. The bathtub drains slowly

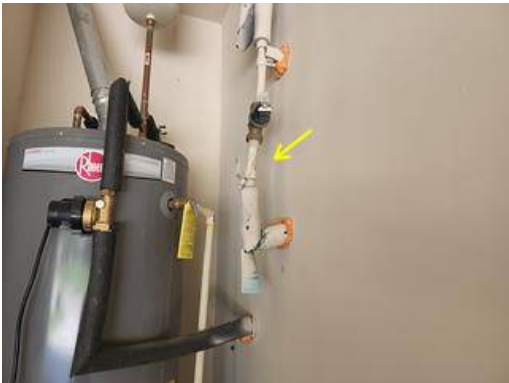
Photo 44-2 Garage shut off location

44) Location of water shut off

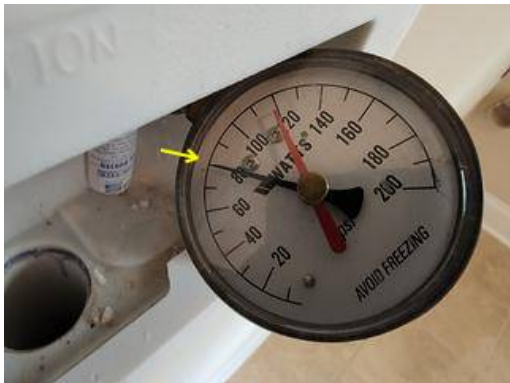
Photo 44-3 Water pressure @ 80psi

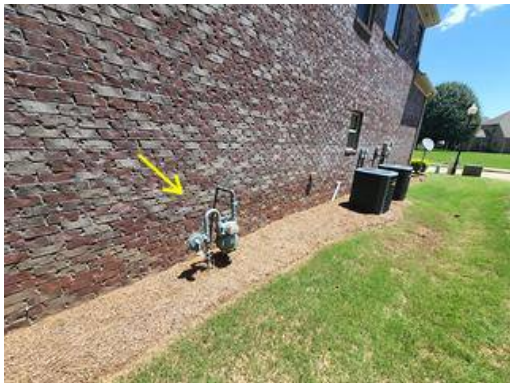
Photo 45-1 Left side of home

45) Location of gas shut off:
