## Chiefs Inspection Services

### Property Inspection Report

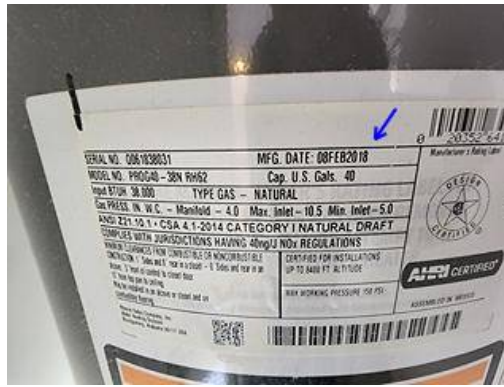
**Photo 14-2** Manufactured 2018  
40-gallon capacity
