## Chiefs Inspection Services

### Property Inspection Report

McDonough, GA

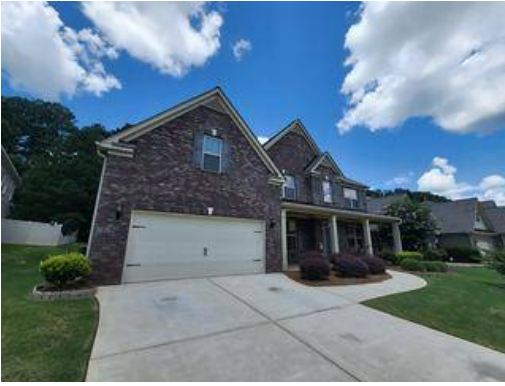
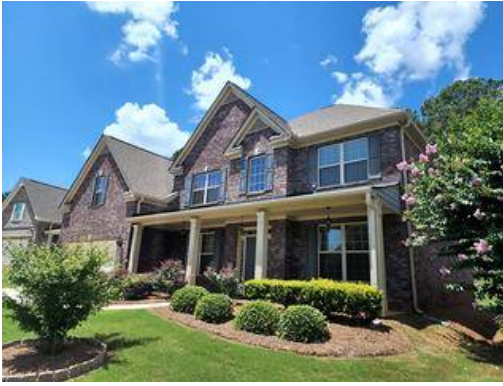
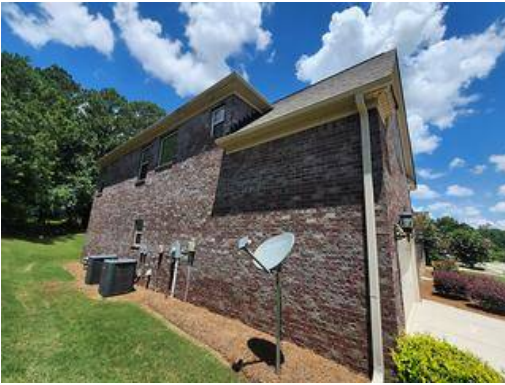
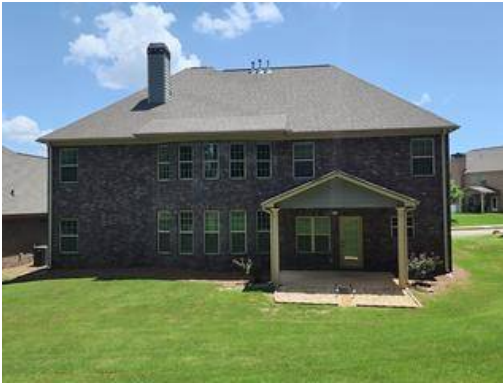
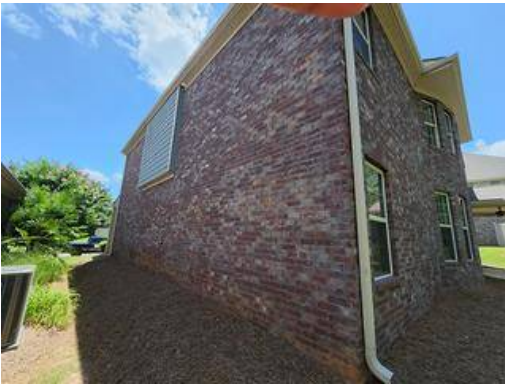
- 
- 7) General pictures of exterior

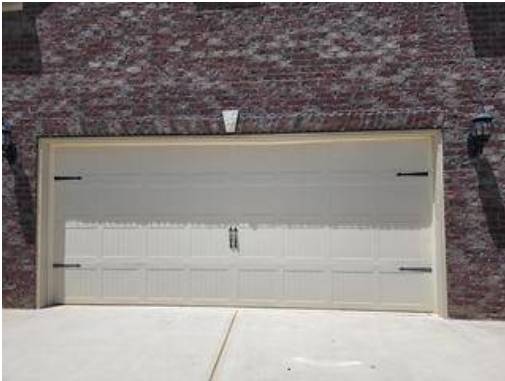
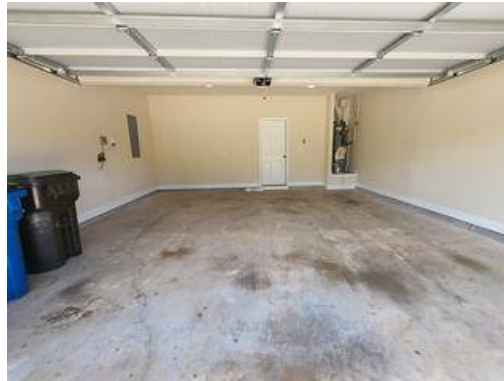
14) General pictures of garage/carport

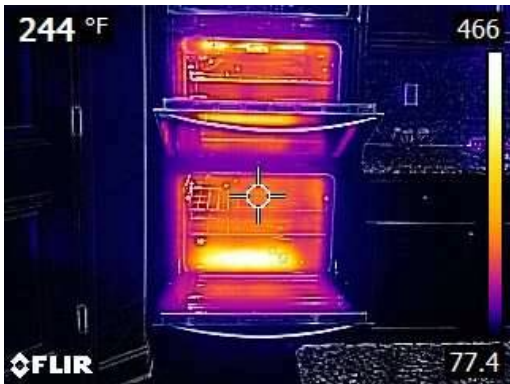
Photo 19-1

19) Oven appeared functional

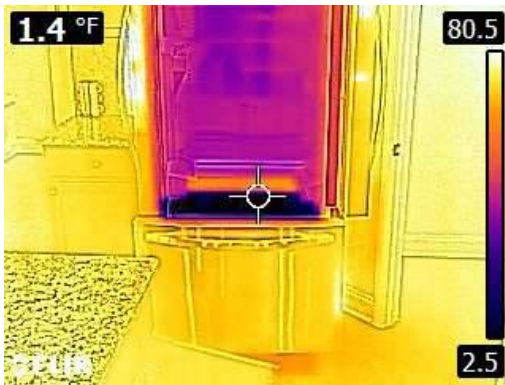
Photo 21-1

21) The refrigerator appeared functional

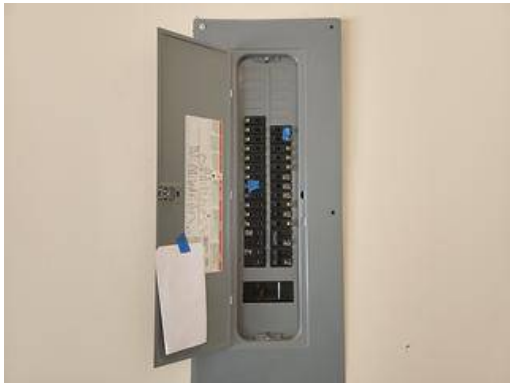
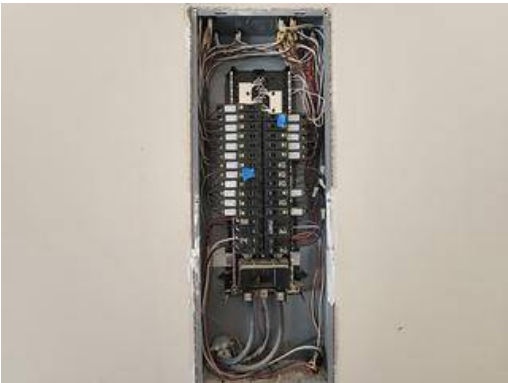
24) General pictures of the service panel showing no abnormal temperature anomalies detected with the infrared camera at the time of inspection.

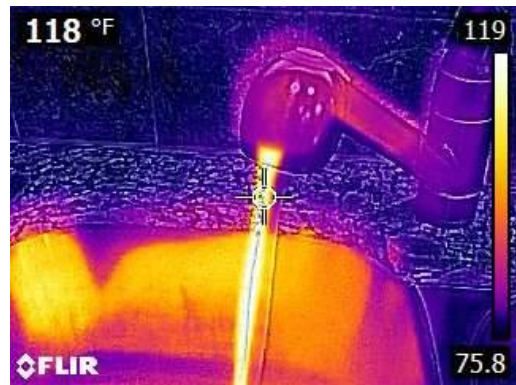
Photo 26-1

26) Water heater appeared functional at the time of the inspection

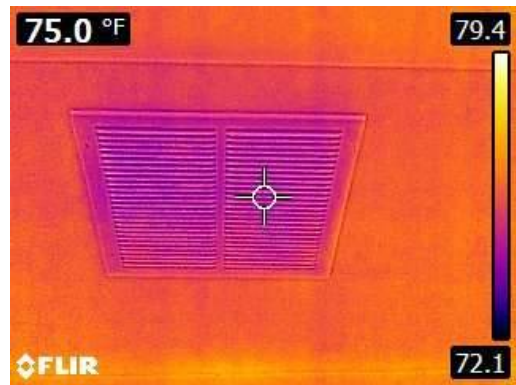
31) A/C unit(s) appeared to be cooling at time of inspection.

To determine if the A/C unit(s) are cooling properly the inspector looks for supply air to be 14 to 20 degrees cooler than the return air.

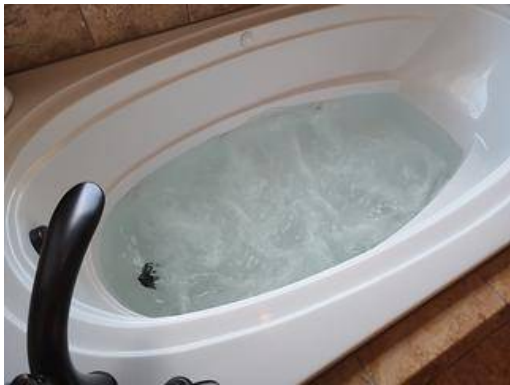
Photo 37-1

- 37) Jetted tub was functional at the time of the inspection

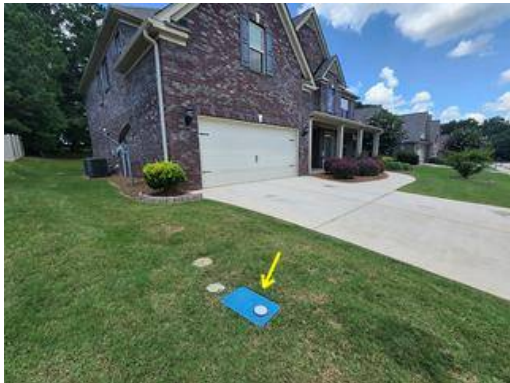
Photo 44-1 Front yard shut off location

44) Location of water shut off
